Powderpost Beetles

Pests that can attack seasoned hardwood timber causing structural damage are of major concern to the householder. Powderpost beetles are one of the borers found in Australia.

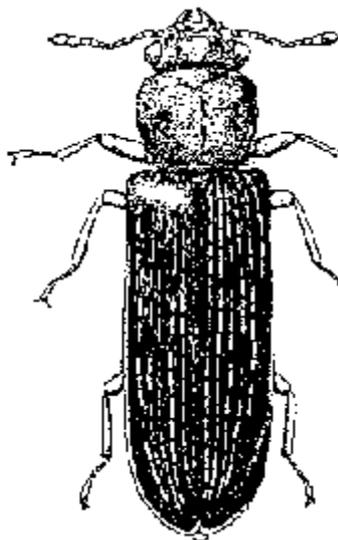
Figure 1. Larvae of powderpost beetles can reduce susceptible timber to a fine flour-like powder.

Powderpost beetles belong to the subfamily Lyctinae in the family Bostrichidae. They are so named because their larvae can reduce susceptible timber to a fine flour-like powder (Figure 1).

Most attacks take place at the saw-mill, in logs or sawn timber that are drying. Evidence of infestation may not become apparent until the timber is in-service and adults begin to emerge. Infested timber contains numerous galleries packed with fine powdery frass. The whole of the infested area may be reduced to powder leaving only a shell of wood on the outside, perforated by emergence holes. Small piles of frass may be found where a gallery has broken the surface or where an adult beetle has emerged. The frass is smooth and floury (not gritty) when rubbed between the fingers.

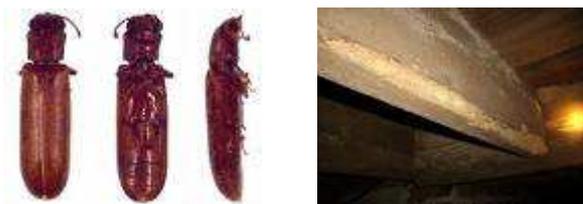
Figure 2. Adult powderpost beetle *Lyctus brunneus*.

Adults are up to 7 mm long, dark-brown, shiny, flattened, elongate insects (Figure 2). They have a distinct head and the terminal segments on their antennae have a clubbed appearance. Larvae are cream-coloured with brown head and jaws and 3 pairs of small jointed legs. On hatching, they are about 0.5 mm long and straight-bodied but later become C-shaped.

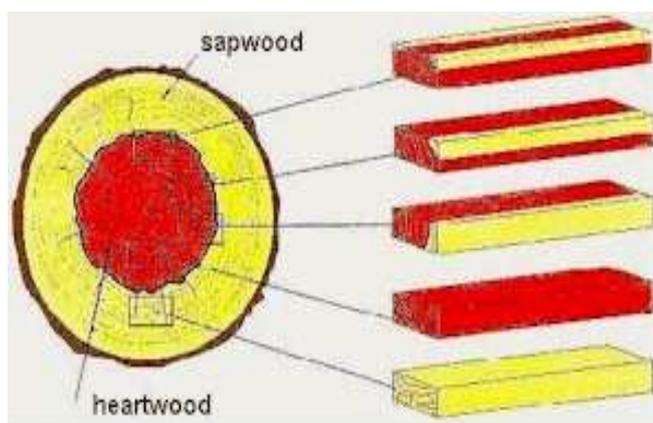
Figure 3. Various sapwood-heartwood configurations can be found in sawn timber.

It is emphasised that lyctine beetles attack only the sapwood (Figure 3) of certain hardwoods and do not attack softwoods.

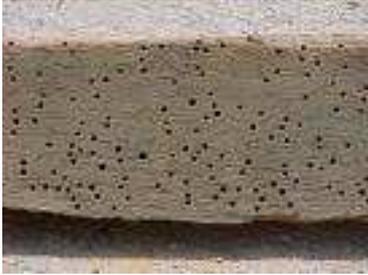
Treatments are sprayed or brushed on to the affected parts of unfinished timber surfaces. All exposed faces of susceptible sapwood should be treated. The insecticide should be diluted in oil or water, although oil-based treatments are preferred because better penetration and persistence will be achieved. Water-based treatments leave most of the insecticide on the surface of seasoned timber.

Emergence through water-based insecticide may continue for many months, but most adults will be killed as they wander over the treated surface. Immature lyctines may survive beyond the treated zone, but their emergence as adults through oil-based insecticide is unlikely. Emergence can continue through non-host materials concealing sapwood surfaces, for example, through the lining attached to ceiling battens.
